# Erosion and Dynamic Beach Hazard Mapping: Supplement to the Essex Region Coastal Flood Hazard Mapping Report

County of Essex and Essex Region Conservation Authority

June 13, 2024

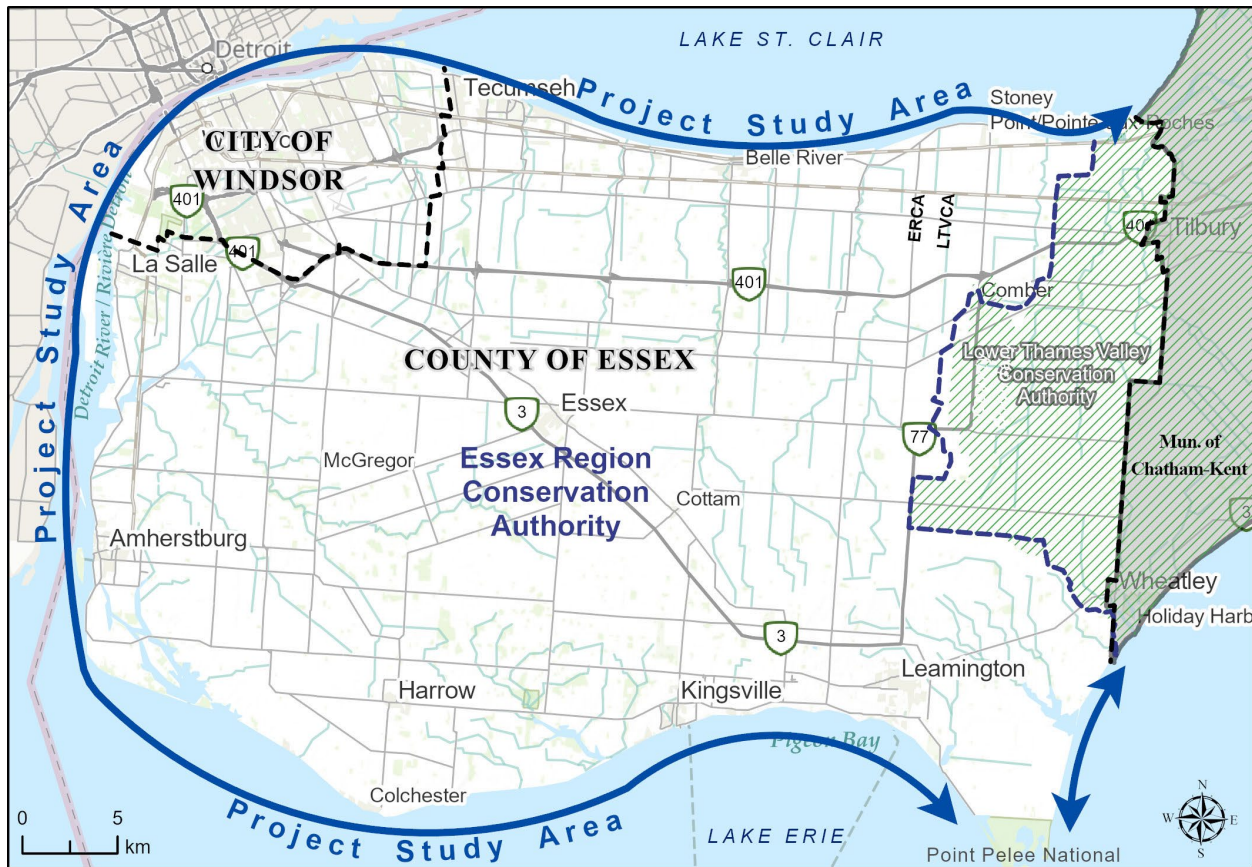
Figure 1.1 Study area

The study area shoreline extends from the mouth of the Thames River in the southeast corner of Lake St. Clair, includes the entire Canadian Detroit River shore, and the Lake Erie shoreline in the western basin and the east side of the Pelee Peninsula to Wheatley. Refer to Figure 1.1.

The majority of the study shoreline falls within the jurisdiction of the Essex Region Conservation Authority (ERCA), with the exception of the northeast corner at the mouth of the Thames, where the Lower Thames River Conservation Authority (LTVCA) regulates shoreline development. The jurisdiction of the LTVCA is hatched in Figure 1.1.

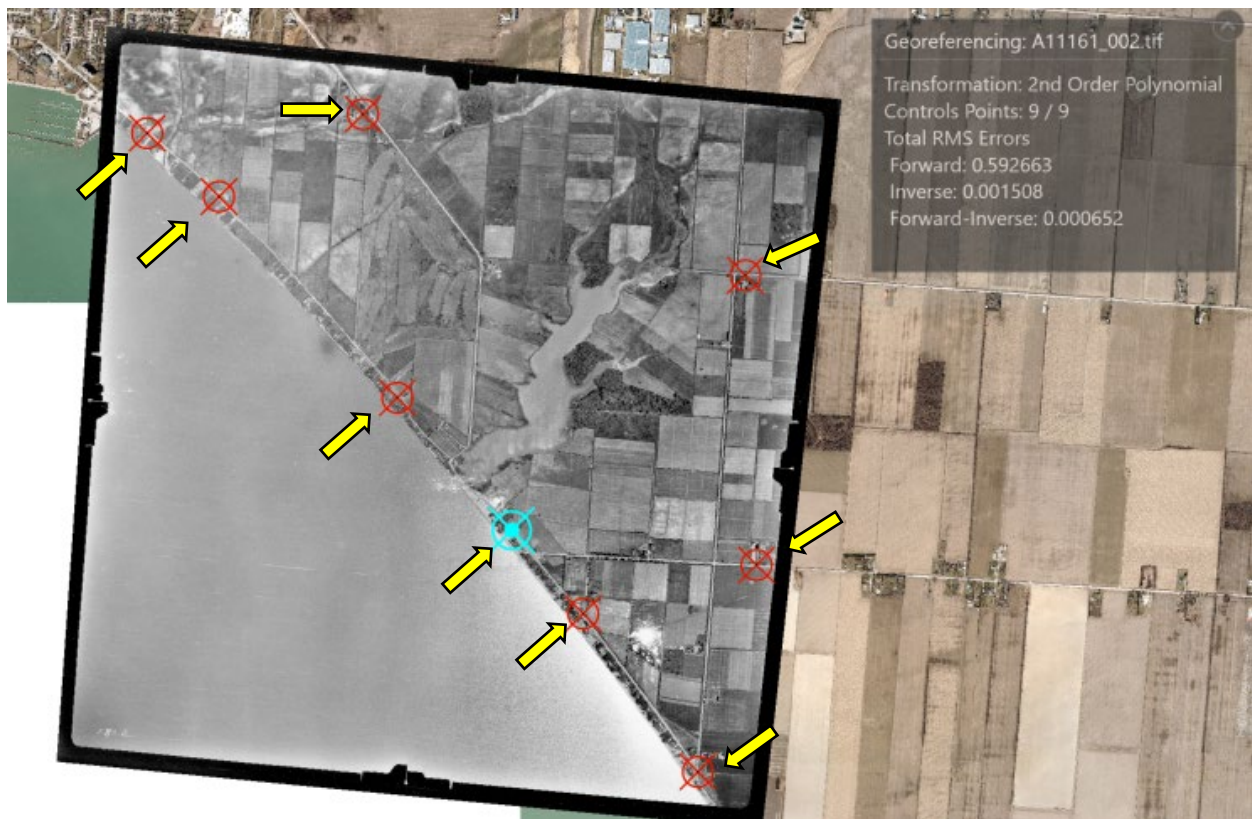
**Figure 2.3 Example of ground control selection during photo registration**

An example of a historical aerial photo included in the registration process is presented in Figure 2.3. The yellow arrows point to the ground control used, which are the red X's. Ground control represents features that are visible in both the historic aerial and the base imagery. To minimize horizontal positional errors in geo-referenced imagery, ground control points were well distributed across the area of coverage, an appropriate transformation method was applied, and routine visual checks against base imagery were completed.

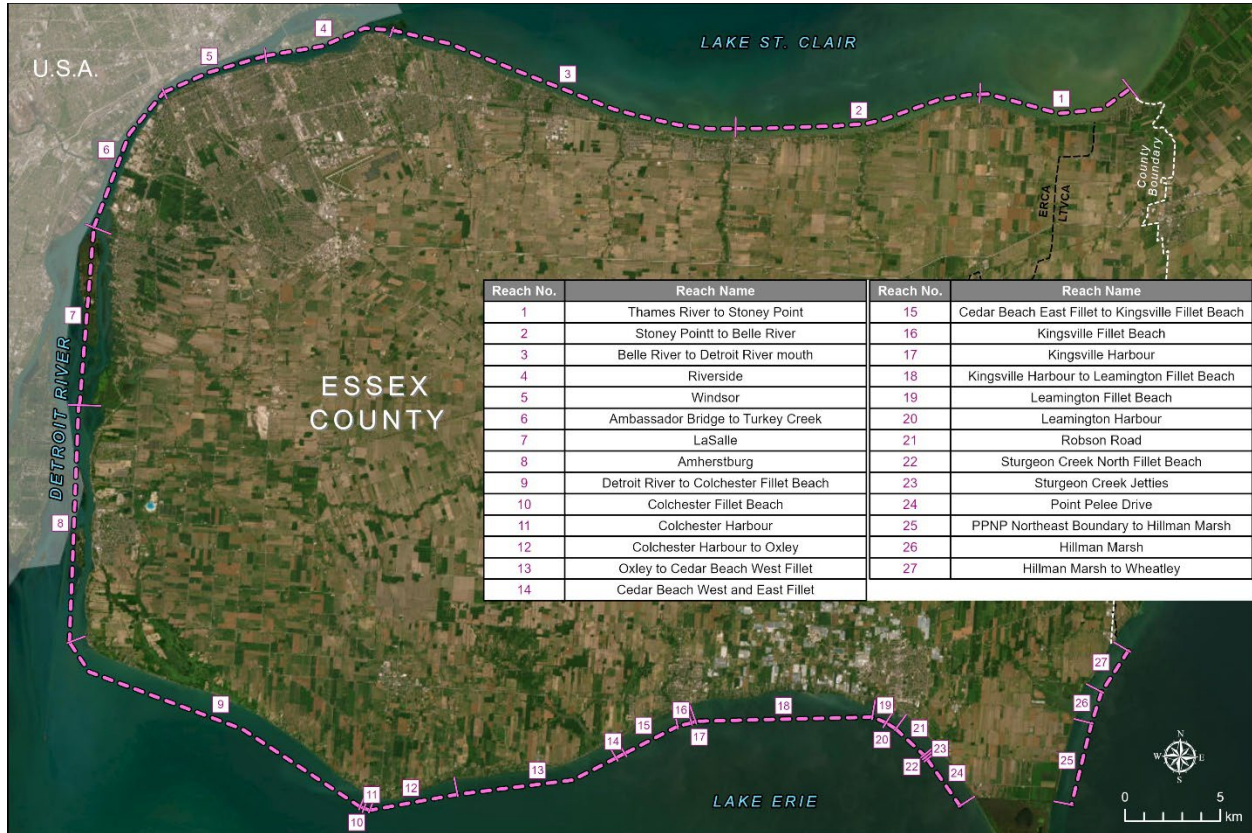
**Figure 2.5 Hazard mapping reaches**

The recession analysis is summarized by reach, which were defined as sections of shoreline with similar exposure to wave energy, shoreline and nearshore geology, shoreline morphology, physical processes such as erosion and deposition, development density, and sensitive ecological habitat. Refer to Section 3.4 of the main FHIMP report for additional details on defining the reach boundaries. For reference, the 27 hazard mapping reaches are presented in Figure 2.5.

The completed shoreline structure inventory was used to assess statistics pertaining to the project shoreline including the percent of shoreline armoured versus natural and the percent armoured by structure type. Statistics were tabulated for each of the 27 project reaches and for the total project shoreline. Refer to Figure 2.5 for the delineation of project reaches.
